New York State Department of Transportation

Yellow Flag NB2358W001

BIN: 1065318

Feature Carried: 278I278IX2M23027

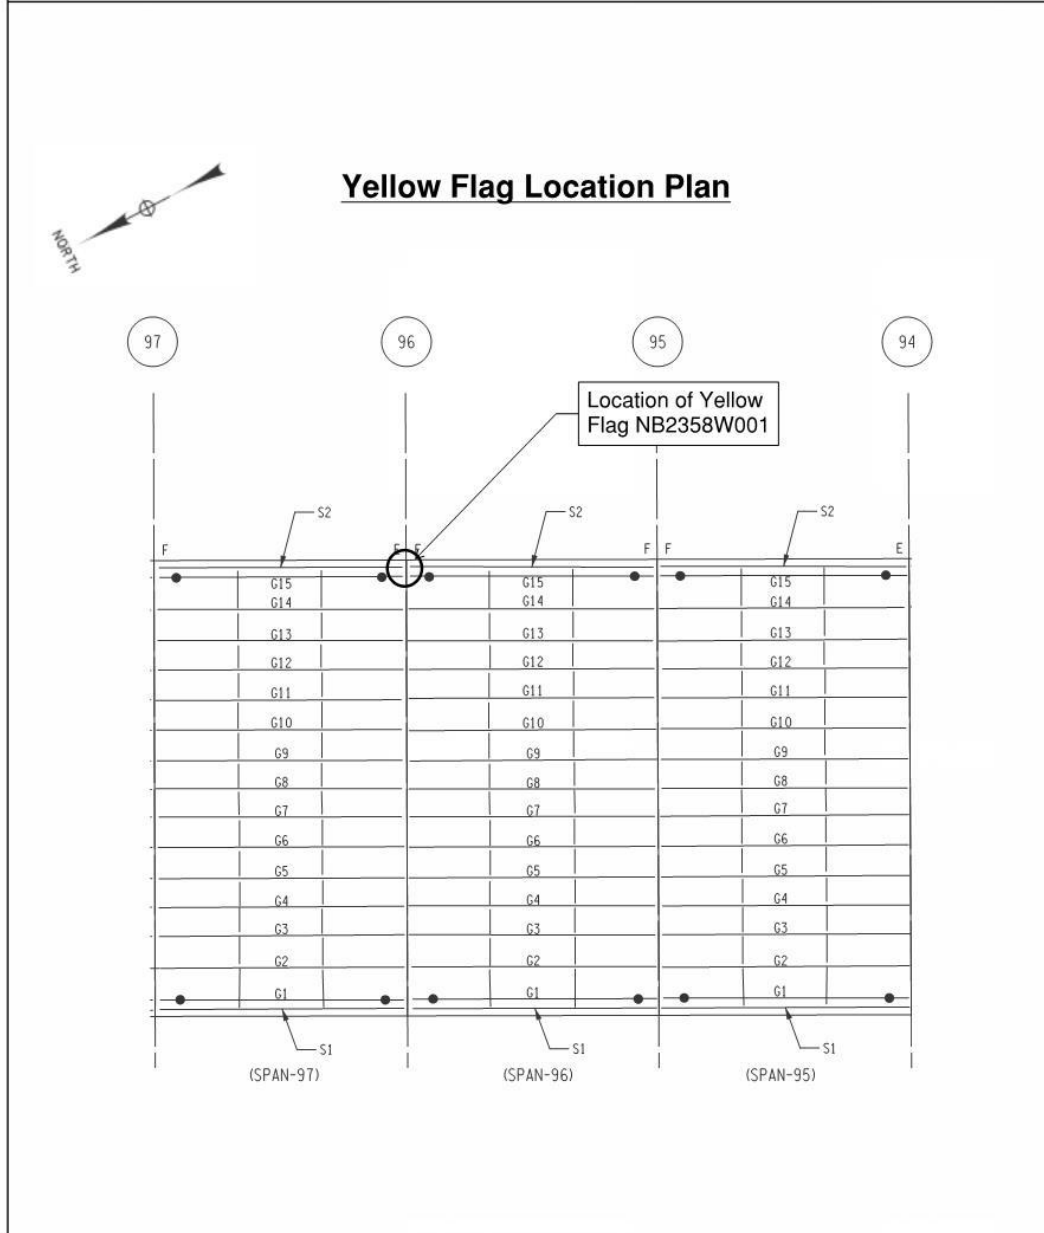
Flag PhotographsPhoto Number: **1**Photo Filename: **23_Flag Location Plan.jpg**Gowanus Expressway
2023 Biennial Inspection - Field SketchBIN: 1065318Team: AA/TSDate: 04/04/2023Span: 96Location: Stringer S2 at Pier 96

**wsp****Attachment Description: Yellow Flag Location Plan**

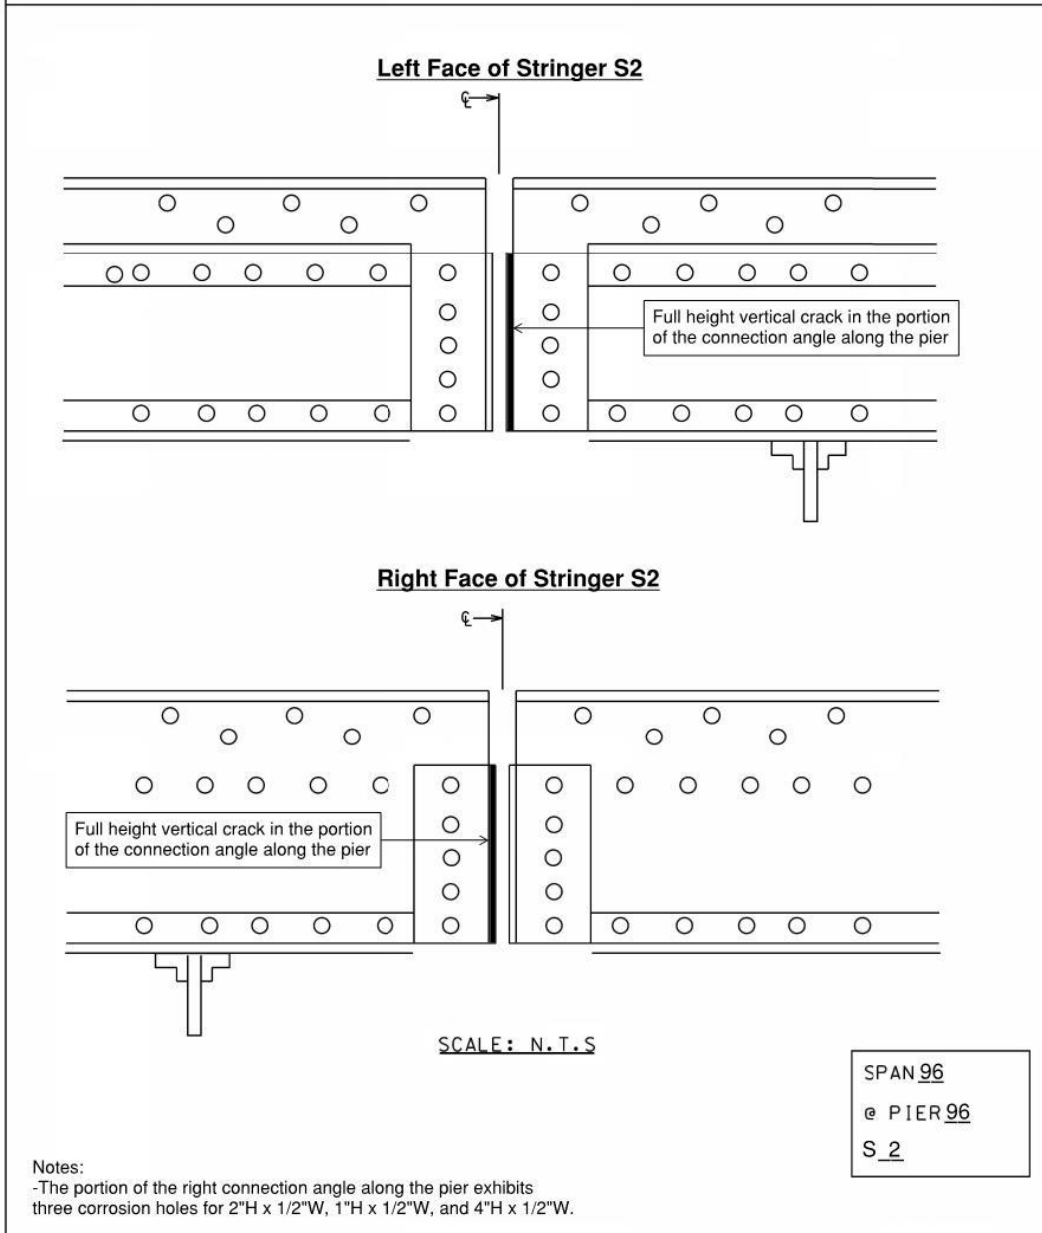
Photo Number: 2

Attachment Description: Yellow Flag Condition Sketch

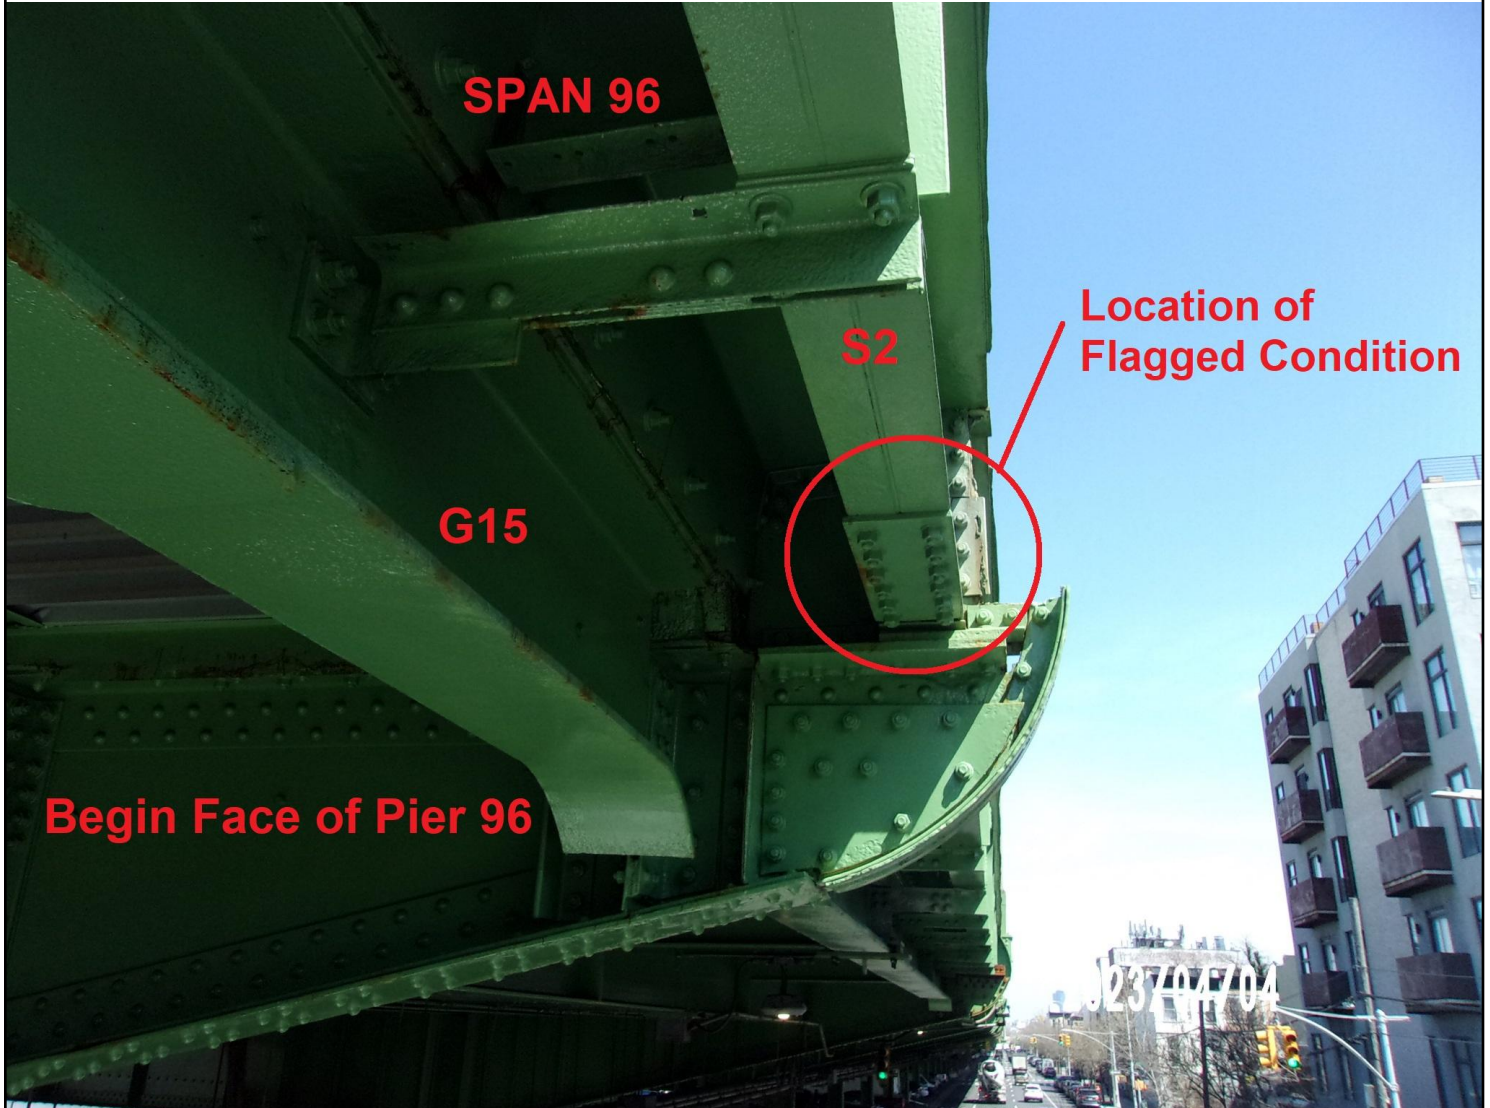
Photo Number: 3

Attachment Description: General view of the flagged condition at Stringer S2 in Span 96 at Pier 96. Looking End.

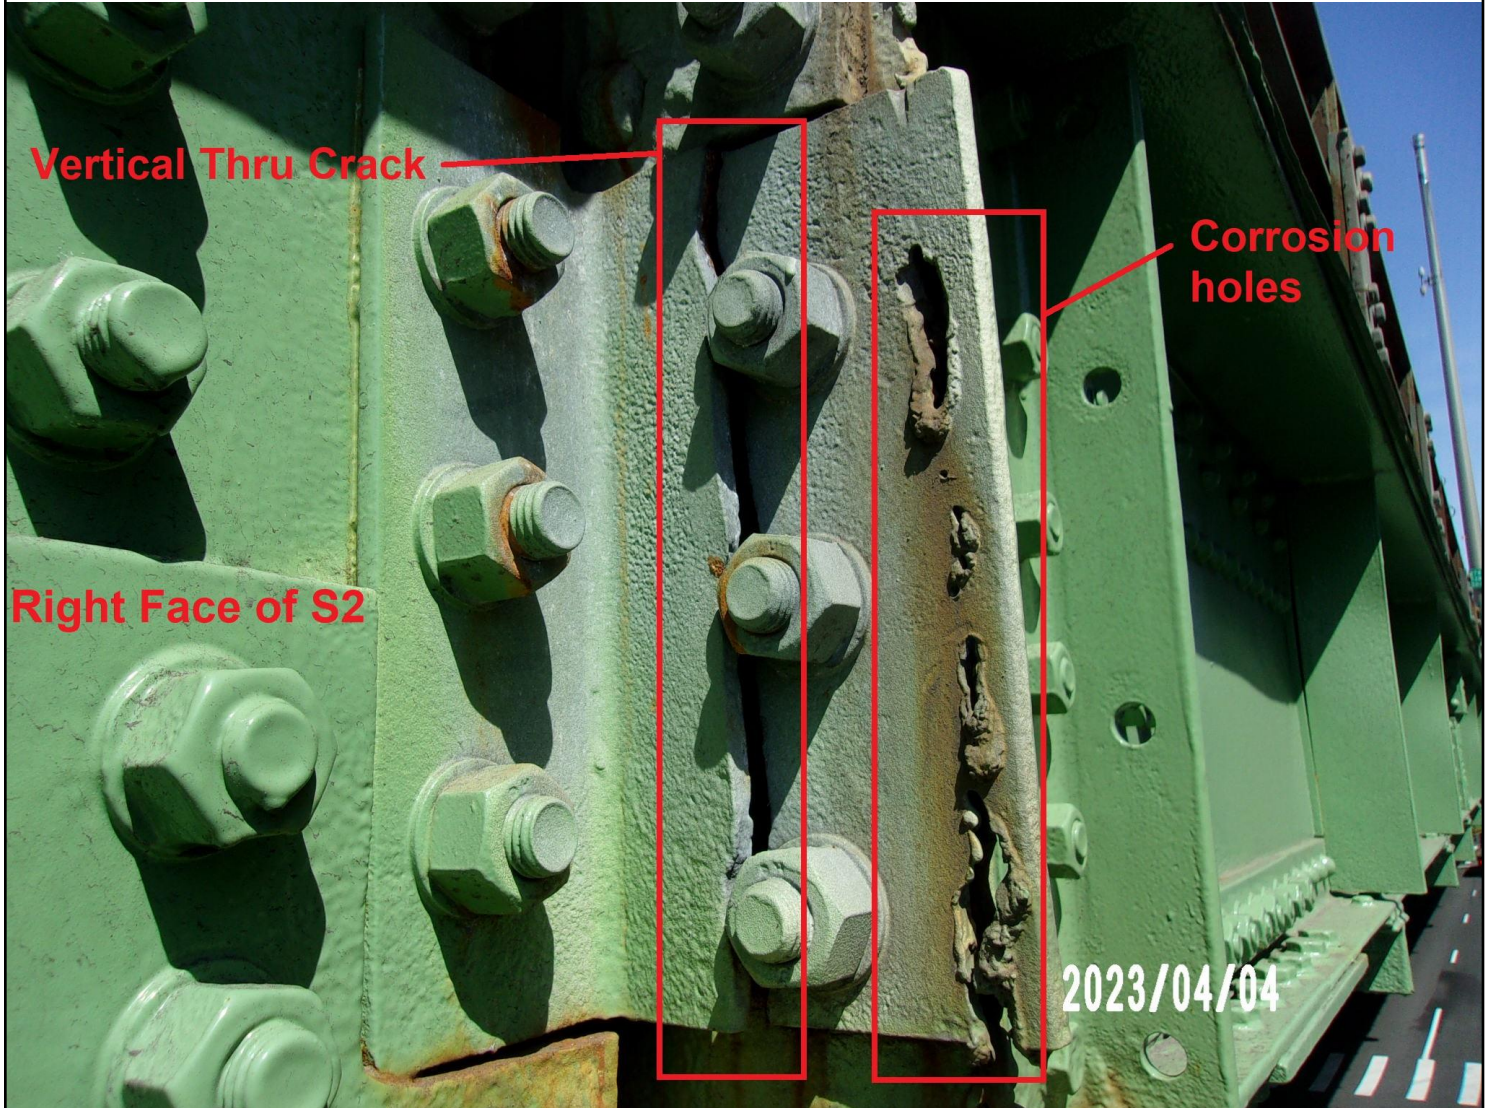
Photo Number: 4

The end of Stringer S2 in Span 96 at Pier 96 exhibits a full height vertical thru crack at both connection angles in the leg of the angle along the pier (Photos 4 and 5). In addition, the right connection angle exhibits three corrosion holes in the leg of the angle along the pier for 2"H x 1/2"W, 1"H x 1/2"W, and 4"H x 1/2"W. The stringer end has previously installed steel reinforcement plates and angles which are in good condition (Photos 6 and 7).

Attachment Description: The right face of Stringer S2 in Span 96 at Pier 96. The connection angle exhibits a full height vertical crack in leg of the connection angle along the pier with three corrosion holes. Looking End and Left.

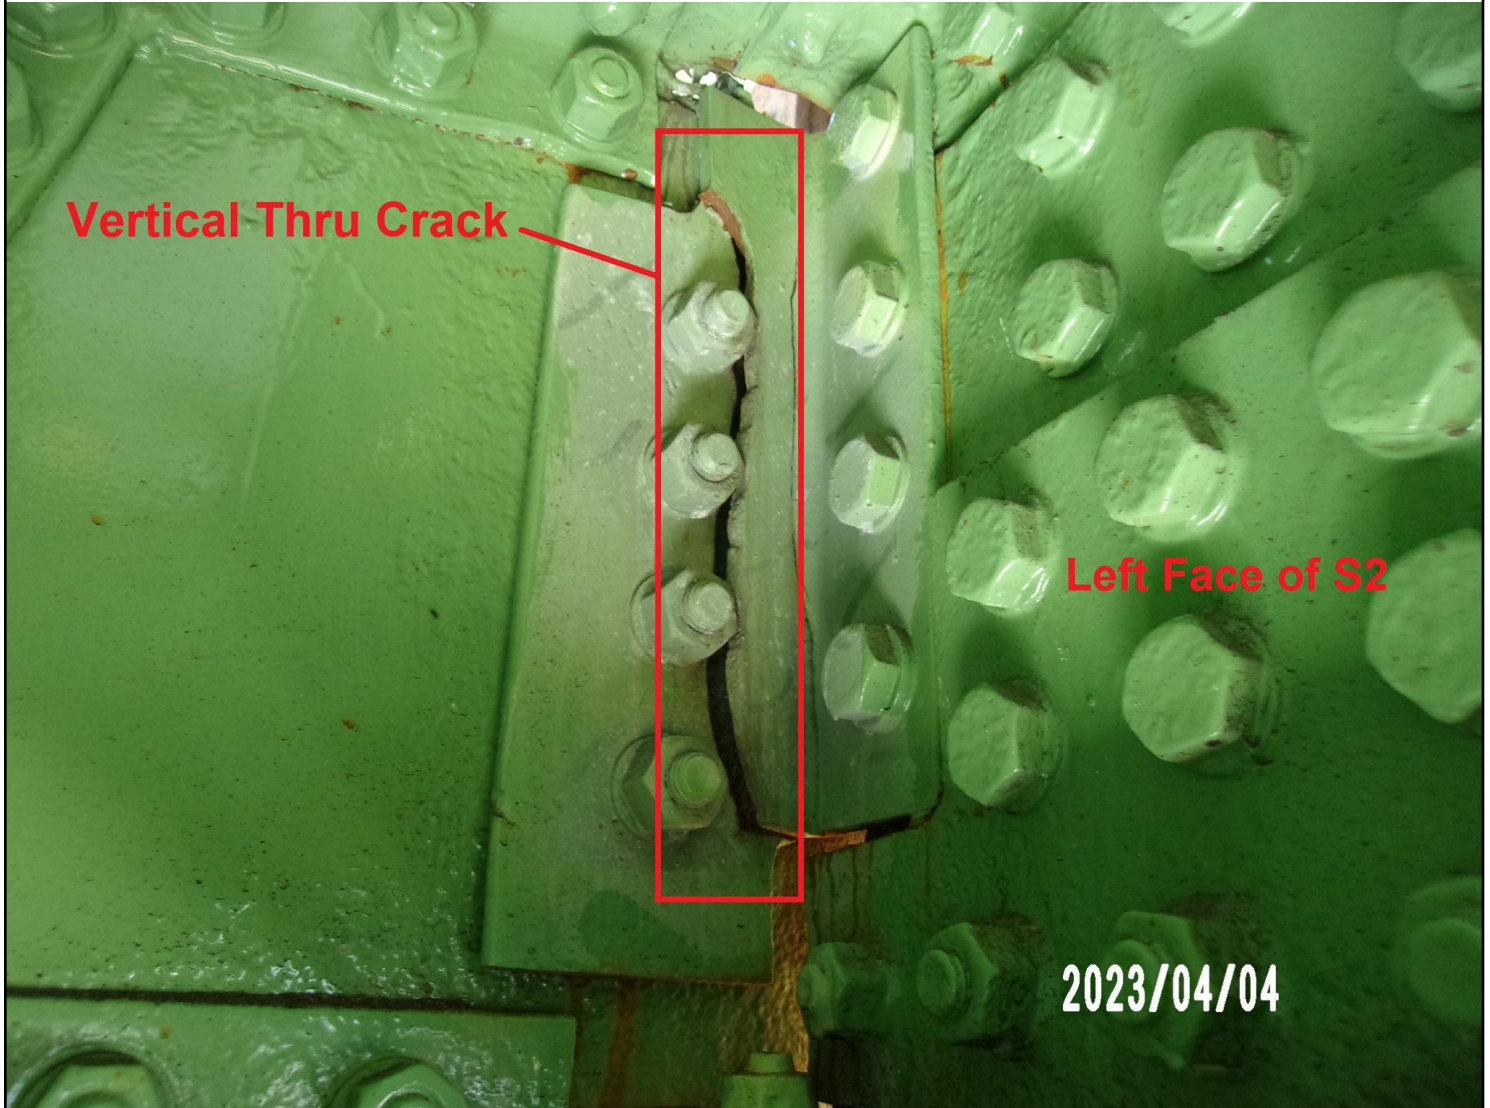
Photo Number: 5

Attachment Description: The left face of Stringer S2 in Span 96 at Pier 96. The connection angle exhibits a full height vertical crack in the leg of the connection angle along the pier. Looking End and Right.

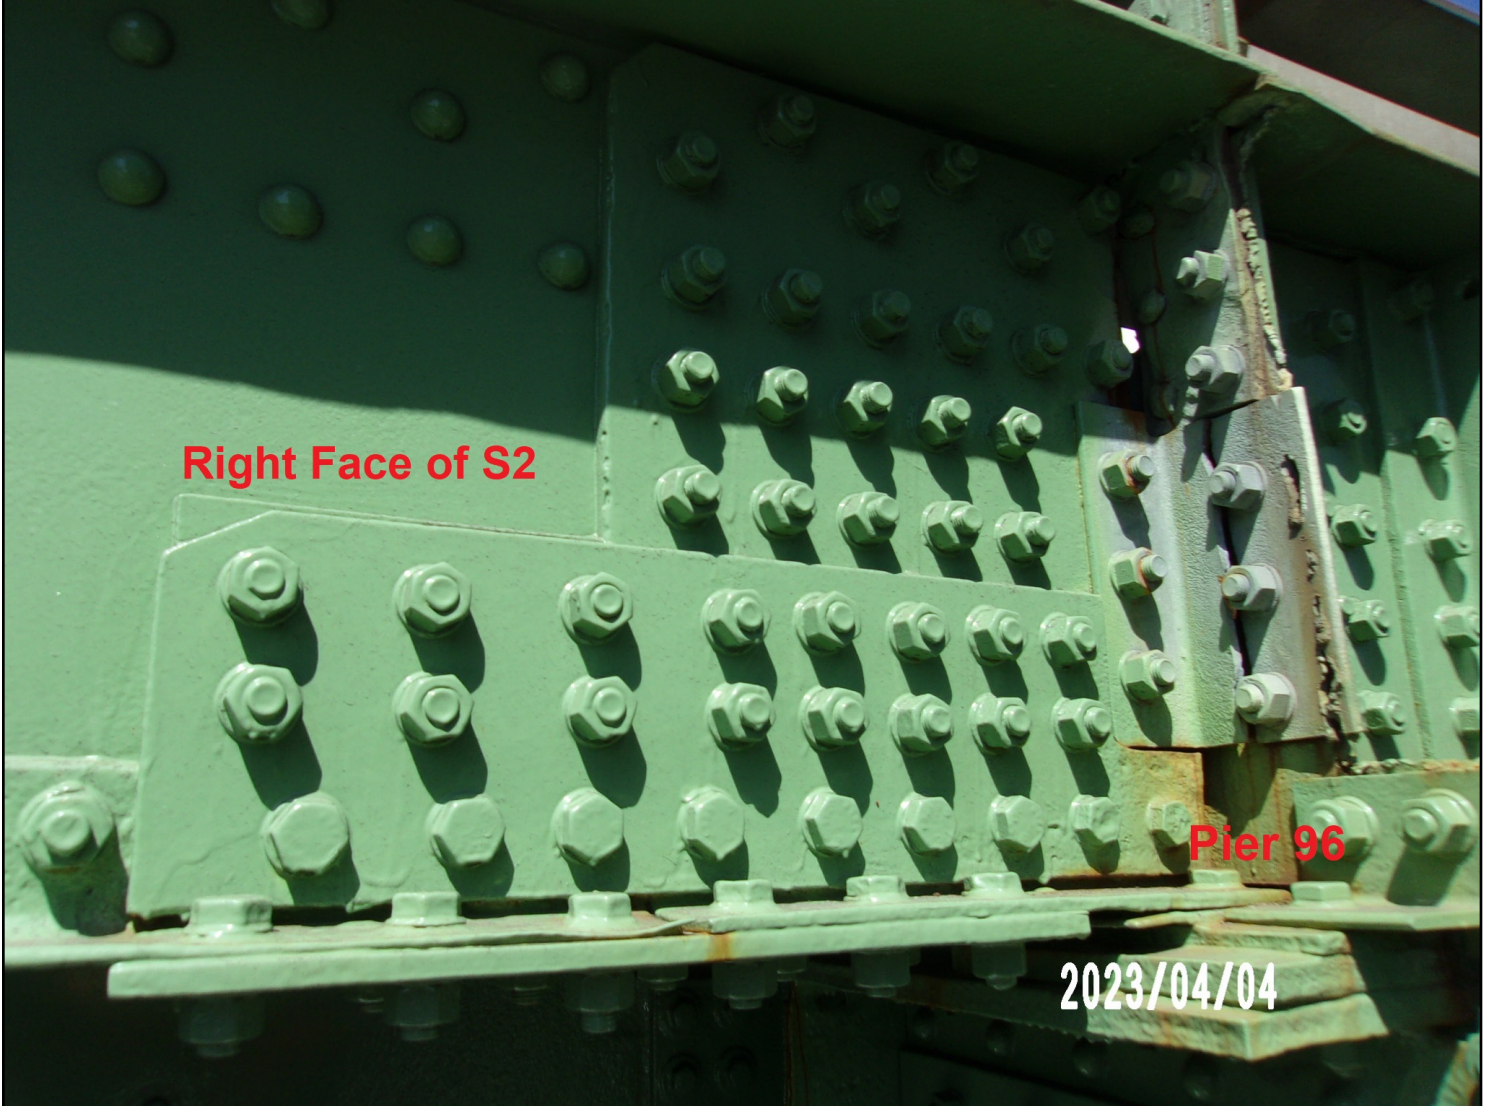
Photo Number: 6

Attachment Description: The right face of Stringer S2 in Span 96 at Pier 96. The stringer end has previously installed steel reinforcement plates and angles which are in good condition. Looking Left.

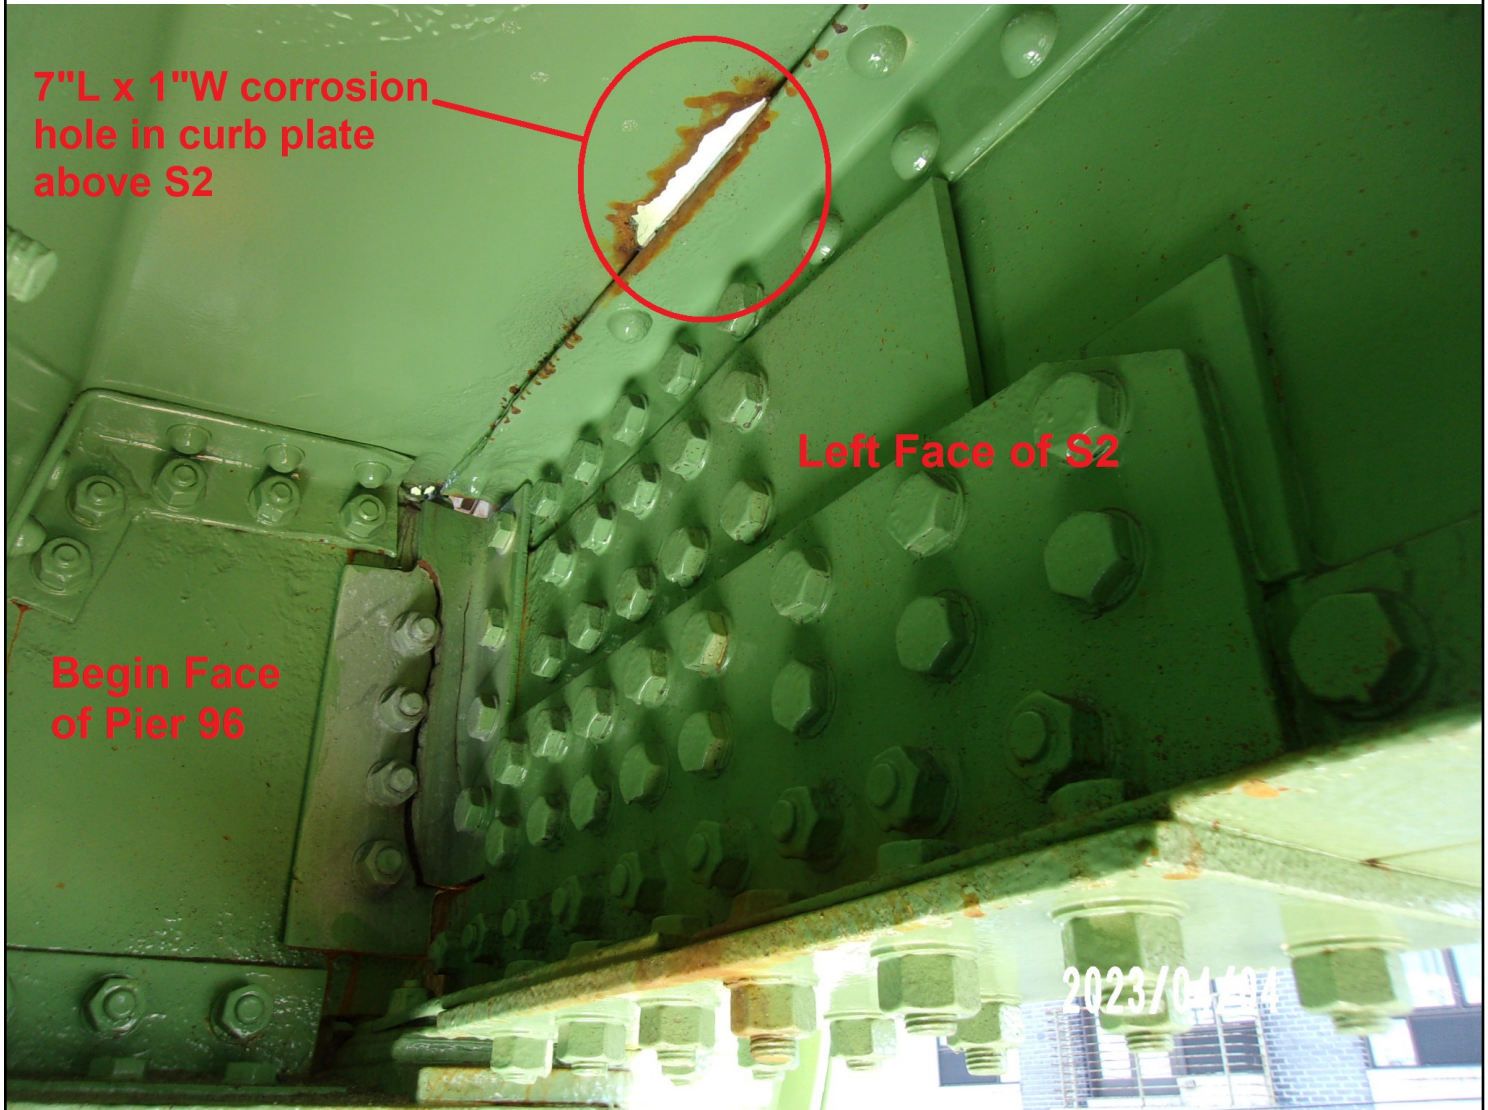
Photo Number: 7

Attachment Description: The left face of Stringer S2 in Span 96 at Pier 96. The stringer end has previously installed steel reinforcement plates and angles which are in good condition. Also, the curb plate above Stringer S2 exhibits 7"L x 1"W corrosion hole. Looking End and Right.
